## Brass And Woodwind Workshop

INSTRUMENT: *Sankyo Etude Flute*

### FULL REPAIR ASSESSMENT

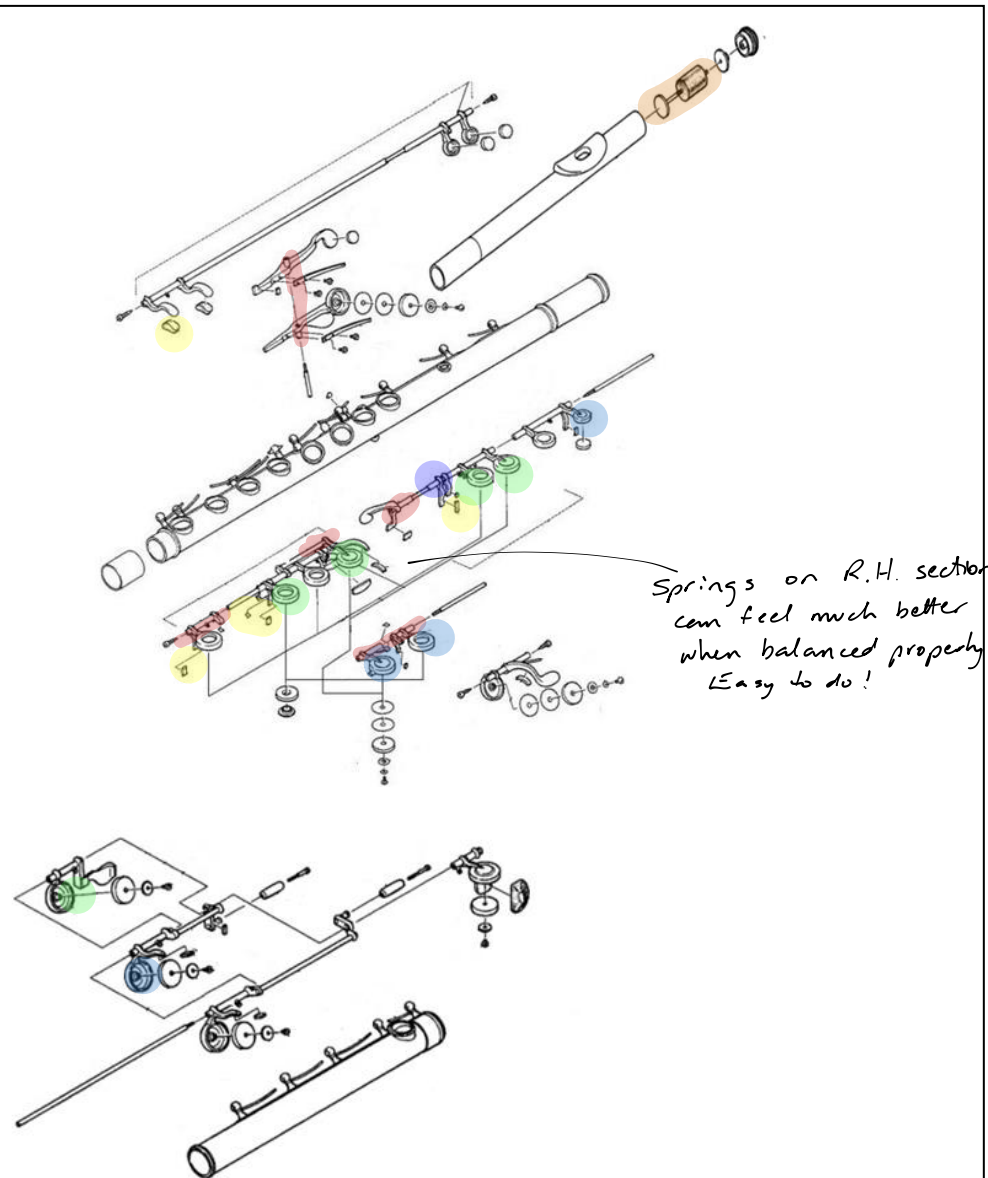
Headjoint work shows signs of water leakage.  
→ Replacing will improve resonance overall.  
Regulation is maladjusted, probably causing loss of resonance and unresponsiveness.

Swedging some of the keys will improve the accuracy of the mechanism and improve the response of the notes.  
Loose pins or worn pin-holes can make the mechanism unstable  
Noise in the keywork caused by slop in the mechanism.

Check and re-set head-joint cork		Replace head-joint cork	●
Re-seat pad and eliminate leaks as per repair diagram. <i>Shims</i>	●	Replace pad, and shim or adjust to ensure proper seat with no leaks. <i>Pads in poor condition.</i>	●
Align bent key-work and/or straightene hinge-tube as necessary		Remove dent as per diagram	
Re-fit loose or poorly fitting tenon as per diagram		Swedge and precision fit key-work	●
Solder part as per diagram		Replace felts and key-corks	●
		<i>Pins</i>	●
